Becoming a Bench Top Clinician

Looking beyond the technical for better esthetic results.

By Joshua Polansky, BA, MDC

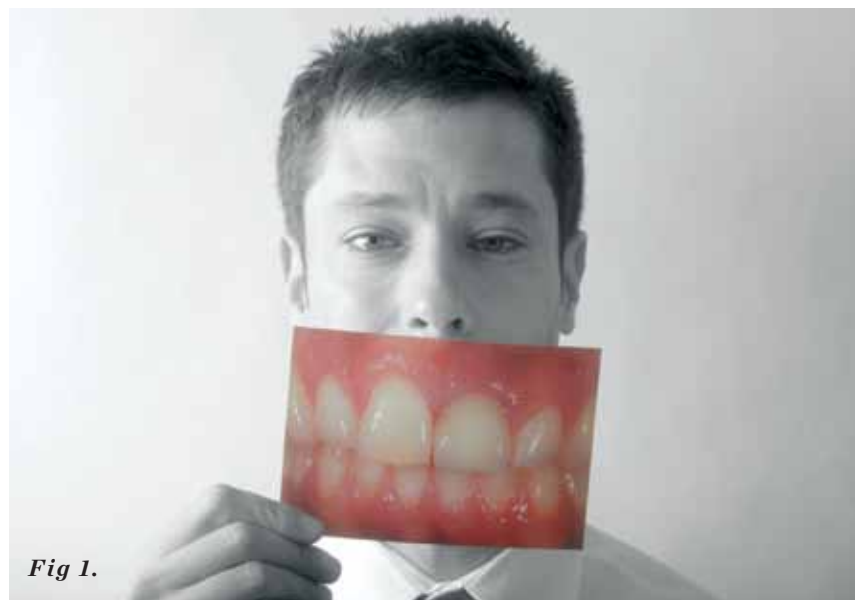
to reflect how happy he was on that day, rather than the unattractive smile he currently possessed. It was obvious that the patient's smile could be improved with additional treatment (Figure 1).

Fig 1. The patient's current situation as identified by another clinic. The patient was unhappy with the overall intraoral final outcome.

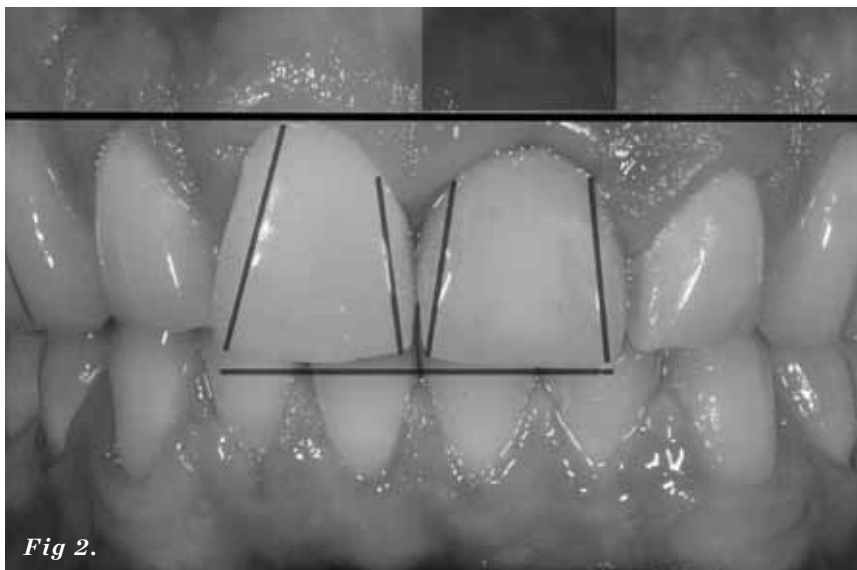
Intraoral photographs revealed details to help the dental team create a greatly enhanced restoration. The patient never mentioned a problem with the color of the restoration; his primary concerns centered on contour, form, and the disharmony created by the less than perfect restoration. Taking this into account, the color intraoral photographs were converted to black and white, which would allow the dental team to assess the patient's concerns (Figure 2). The black-and-white image showed that the restoration did not have the same form as the patient's natural dentition. Graying under the tissue from the metal abutment, an obvious tissue-level discrepancy, was also noted.

Fig 2. Getting away from color, the overall situation was analyzed. Form was an issue that had to be addressed to achieve success.

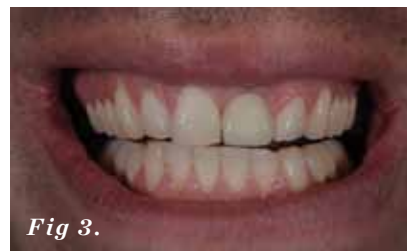
Technicians are inclined to look only at the model when restoring a case. However, to really achieve winning restorations, the patient's entire oral environment—including the tissue, lip line, and smile—needs to be studied. It was evident when examining this patient's lip line at full smile that the tissue-level discrepancy had to be addressed in order to reach an ideal outcome (Figure 3). Using photography to communicate the team's concerns aided in educating the patient. After being shown the intraoral images, the patient agreed with the dental team that in order to fully restore his situation, not only did the form of the restoration

Fig 3. The smile view shows the lip line issue that the team was faced with.

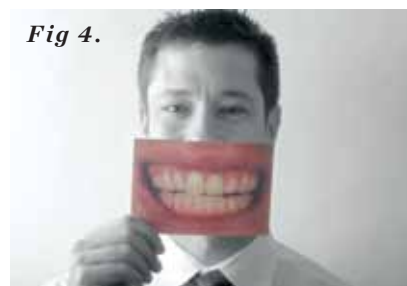
Fig 4. After reviewing the findings with the patient, he realized the treatment necessary to correct his current unesthetic overall appearance.

need to be reworked, but the form of the surrounding tissue also needed to be corrected. Once enlightened, the patient was ready to proceed with the necessary treatment (Figure 4).

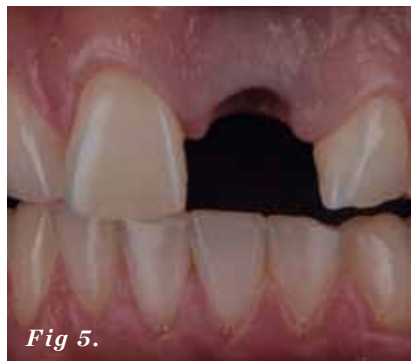
After the patient accepted the plan, the first step was to identify the type of implant placed. To obtain the necessary parts, the surgeon who placed the implant was called. The clinician removed the old restoration and observed the form of the surrounding tissue. It was very clear that the tissue-level discrepancy needed to be modified for an optimal case outcome (Figure 5). To save time and extra expense, the clinician was very careful when removing the old restoration so that the existing implant abutment could be salvaged (Figure 6). If necessary, a temporary abutment was available for placement.

Fig 5. The removal of the old crown revealed the tissue line discrepancy.

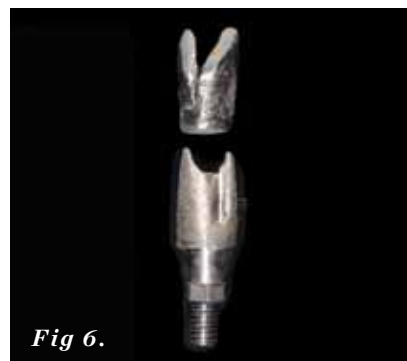
Fig 6. The doctor did a great job of salvaging the old abutment from the previous treatment. This abutment could now be used for the temporary phase.

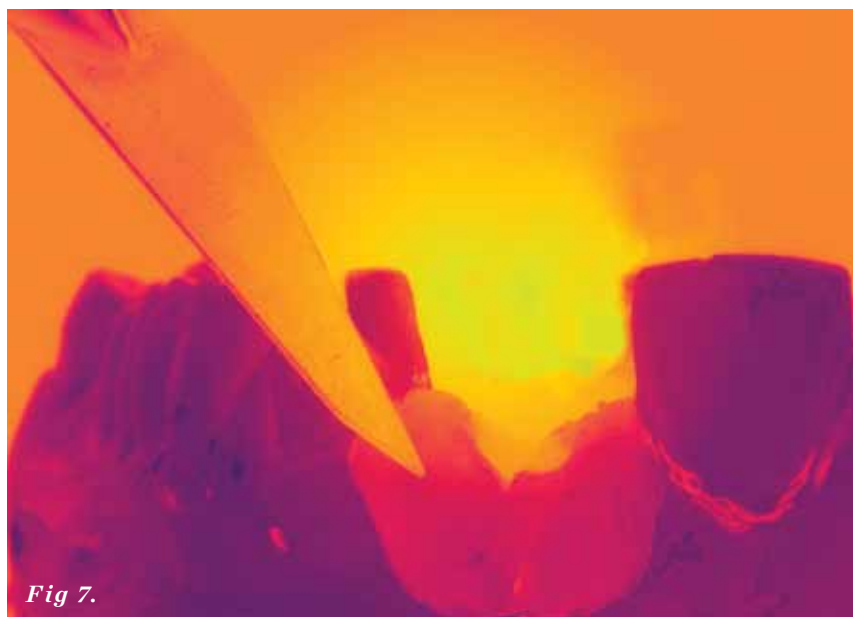
Fig 7. The soft tissue on the model could now be modeled to ideal contour.

With the old abutment and a soft-tissue impression of the existing situation, the technician could now go to the bench and, using a scalpel, contour the tissue on the model to ideal contours (Figure 7). The technician used the old abutment to recontour the sulcus area to a new ideal situation. This was done by priming the old abutment using GC Metal Primer II (GC America, www.gcamerica.com) and adhering composite (GC Gradia) to the abutment to create the optimal sulcus contour (Figure 8). Once the tissue and sulcus modifications were completed on the model, the technician could now fabricate an esthetic temporary as well as build the tissue simulation (Figure 9). An esthetic temporary was fabricated using Anaxdent New Outline acrylic (www.microstardental.com) with a highly polished custom temporary abutment (Figure 10).

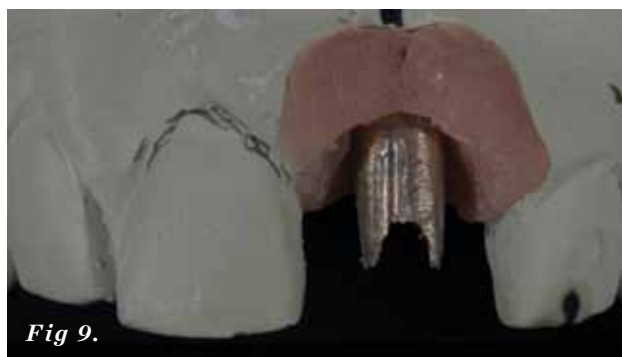
Fig 9. An ideal model was created to fabricate the temporary crown.

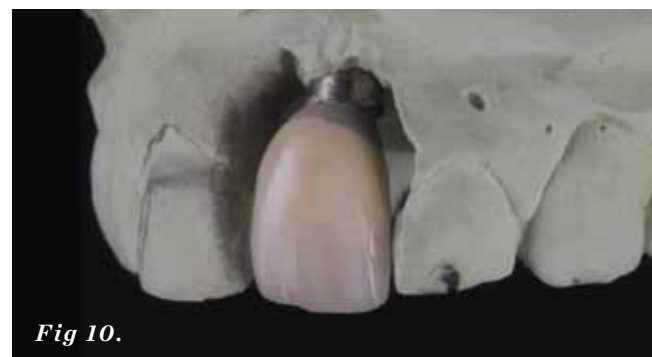
Fig 10. A highly esthetic temporary was created using New-Outline from Anaxdent.

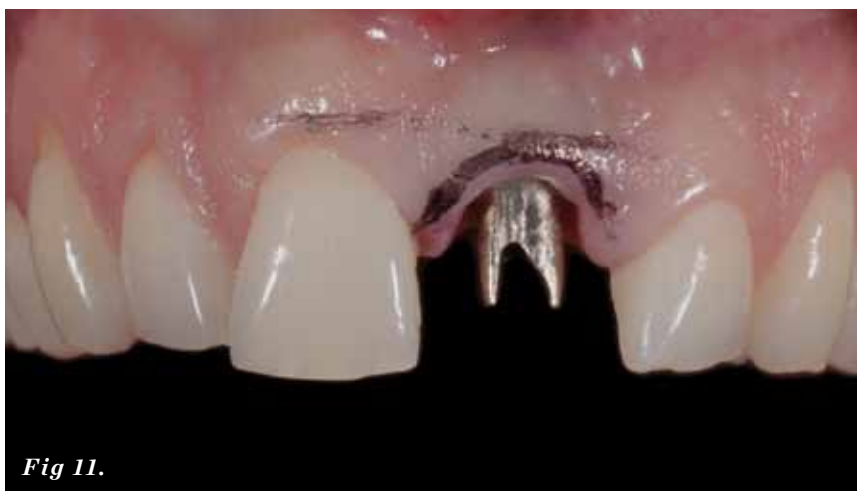
Fig 11. The tissue was marked for the ideal height of contour for the doctor.

The bench-top work completed by the technician could now be transferred to the patient's mouth. The clinician placed the new temporary abutment in the mouth and marked the tissue contours for cut-back (Figure 11). The tissue was contoured using a DEKA CO₂ soft-tissue laser (DEKA Laser Technologies, Inc., www.dekalasers.com). Once contoured, it became clear that the highly polished composite margin was ideally placed (Figure 12). The clinician used temporary cement to secure the provisional restoration in place and begin the tissue-healing phase of the treatment (Figure 13). The patient returned a week later for a clinical monitoring of tissue progress. For the dental team, it was important to observe not only that the tissue was healing nicely, but also that the form and color of the temporary matched the patient's expectations of the final case outcome (Figure 14). The team wanted to be sure it was headed in the right direction in terms of form, value, and tissue height (Figure

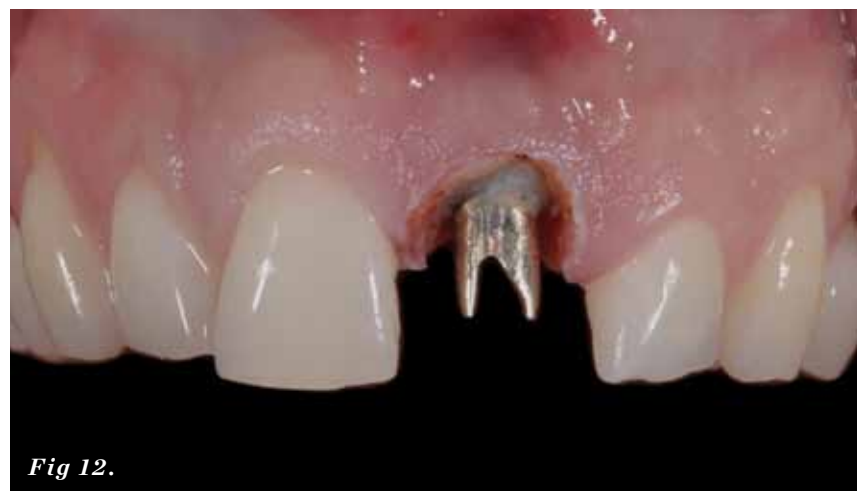
Fig 12. The tissue was contoured to the ideal highly polished Gradia custom abutment. The margin was in its ideal proposed place from the model.

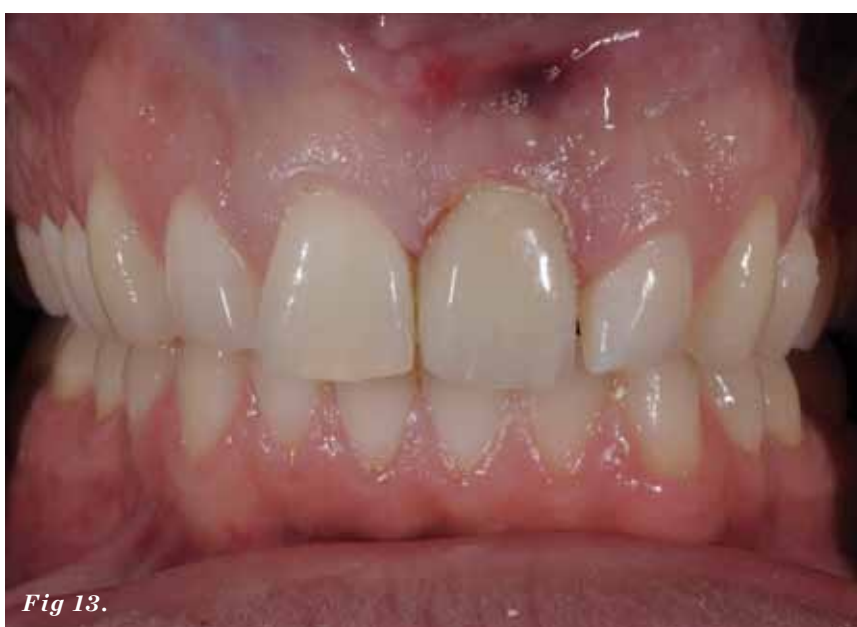
Fig 13. The temporary after immediate seating.

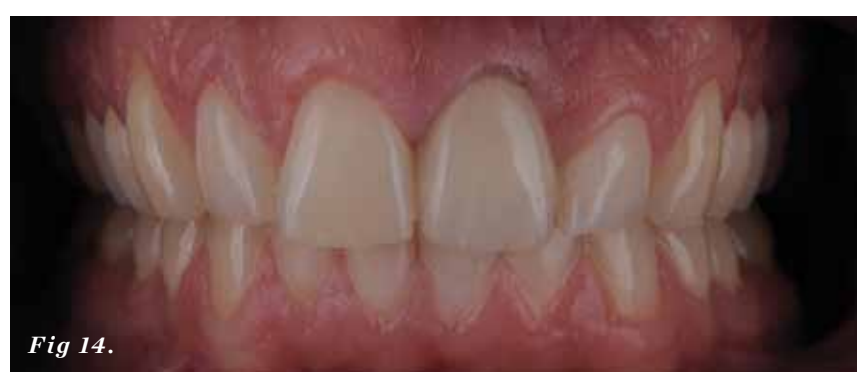
Fig 14. The temporary after 1 week. The patient now had a better visual idea of the final outcome.

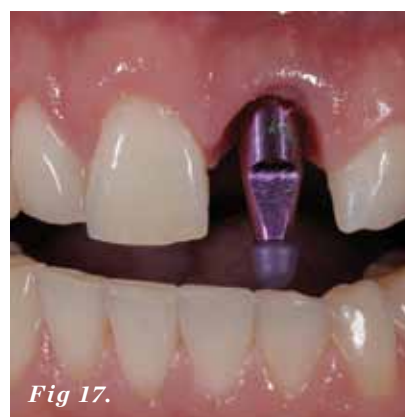
Fig 16. and Fig 17. The ideal sulcus from the model the temporary was fabricated from was used to pick up an accurate impression. This was achieved by placing GC pattern resin in the sulcus of the soft tissue with the impression coping in place. This impression coping could then be transferred to the mouth for the final pick-up.

Confident that the patient's expectations had been met, the clinician took the final impression at the next appointment. The current sulcus diameter that was achieved with the new temporary was used to transfer the patient's new situation. This was accomplished by placing the transfer coping back on to the model and filling the sulcus with Pattern-resin (GC America, www.gcamerica.com) (Figure 16 and Figure 17). This technique allowed for an exact pick-up of the patient's new condition. All of these details were extremely important for creating the design for a patient-specific custom ceramic abutment. A zirconia ceramic custom abutment would not only help the dental team achieve a good biologic environment, but it would also help the contour of the final restoration as well.

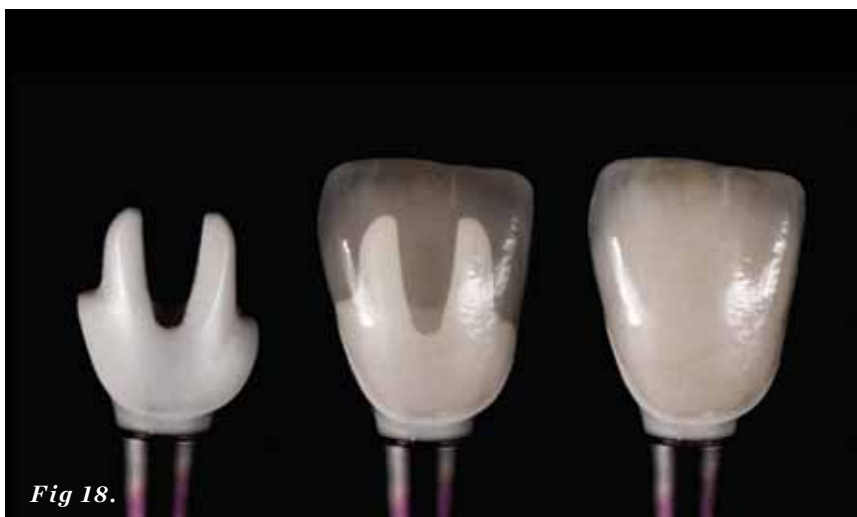
Fig 18. With all the information gathered to this point, the team had a clear vision of abutment, form, and color for the final restoration.

The final outcome of the case was based completely on the temporary abutment and the temporary restoration (Figure 18). The model was shipped to Atlantis (www.astratechdental.com) for the CAM-milled ceramic abutment. The abutment design was based on the contour of the temporary to guarantee the proper dimensions needed for layering ceramics (Figure 19). The abutment design presented to the dental team by Atlantis was meticulously inspected prior to the milling process to ensure that there was adequate space for layering ceramics based on the design of the temporary and to check the functional aspects of the case as well (Figure 20).

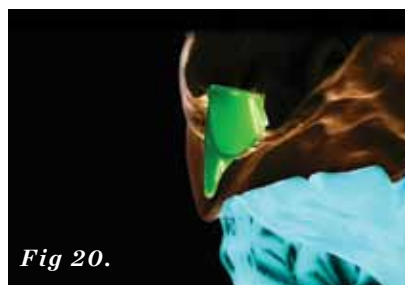
Fig 20. The information not only determines the design of the final restoration, but occlusal clearance as well.

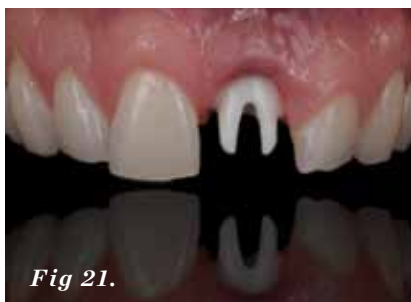
Fig 21. A check of the ceramic abutment in the mouth.

When the milled ceramic abutment was returned, the team checked it against the design specifications

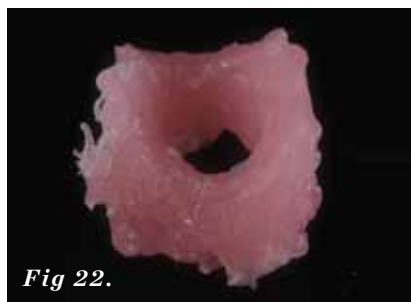
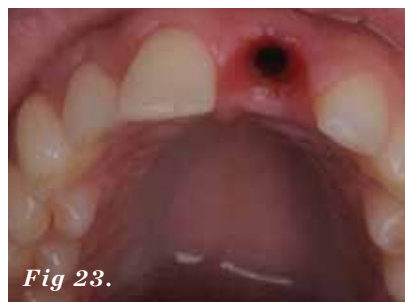
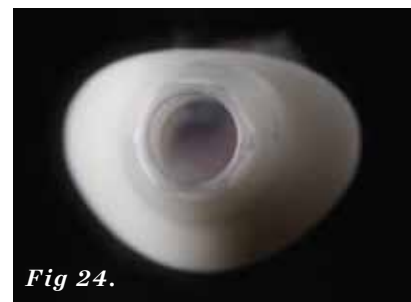
Fig 22 through Fig 24. A check to see that the desired sulcus development was achieved.

(Figure 21). It was critical that the abutment not only possessed the desired room for occlusion and ceramics, but that the sulcus was developed as planned (Figure 22 through Figure 24). With all these details checked, the technician could now begin the final layering stage. Although much care and energy had gone into tooth form and tissue development, it was critical that in order to go to the final stages of layering, an accurate shade image be taken to achieve a successful outcome. To determine the final shade, a value shade was obtained and custom shade tabs were used to visualize the final restoration (Figure 25 and Figure 26).

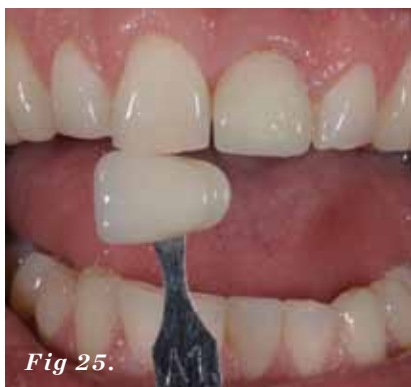
Fig 25. A shade image was taken to obtain the value and determine the custom ceramics that would be used.

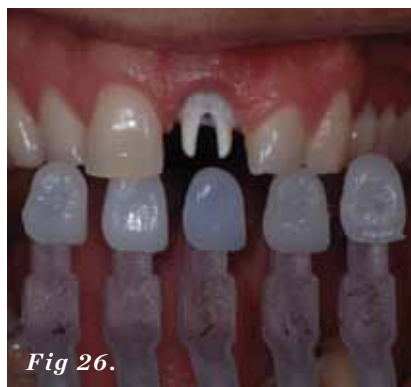
Fig 26. The custom shade tabs were achieved using the My Shade Tabs from Smile Line USA.

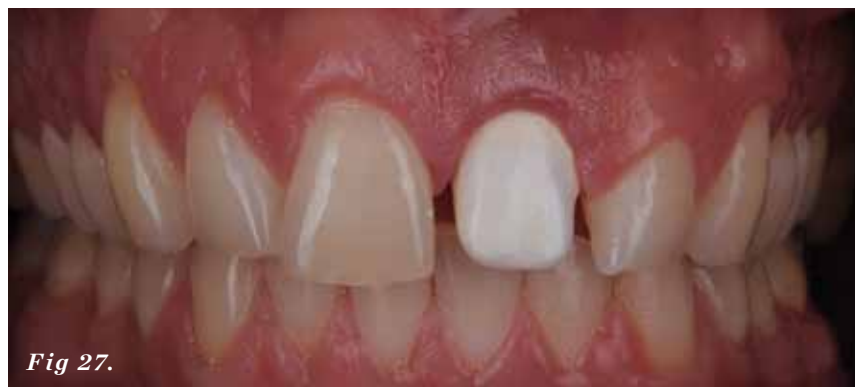
Fig 27. Fluorescent modifiers were applied to the zirconia coping to help scatter light deep within the restoration.

Build Up Technique (Quintessence Publishing, www.quintessence.com), it is clear that each ceramic layer is critical to the final outcome. Often the core, opaque, or bonder layer is overlooked by technicians in the ceramic build-up phase. However, this layer is extremely important because it allows natural light to scatter and reflect, helping to give the restoration a more vital appearance. For this case, light reflective liners were applied to the frame modifiers (GC America Zirconia light reflective liner kit). To achieve a nice foundation, GC Initial ZR base layer L-2 was used for the cervical portion of the coping as well as for highlights on the interproximals and where the mamelon structures would appear. The remainder of the coping was coated with GC Initial L-BL (Figure 27).

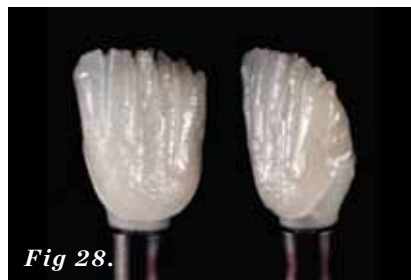
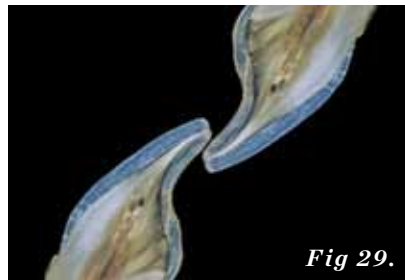
Fig 28.

Fig 28 and Fig 29. A study of the layered crown shows a deep understanding of the observation of natural dentition.

With the base layer placed, polychromatic ceramic layering was begun always following the principles of nature (Figure 28 and Figure 29). Although the proposed restoration was a basic A1 shade, a deep understanding of a segmental ceramic layering technique should be understood. The layers of deep dentins, modifiers, enamels, translucence, and opalescent ceramics are catalysts for the diffusion, transmission, and scattering of light that will allow for a life-like restoration. Figure 30 shows the segmental layering for the proposed restoration. Note the multiple layers of dentins, effects, and opals used to achieve the final result. Once the ceramic layering was complete, the crown was tried in for final analysis (Figure 31). For this analysis, the team looked at the overall natural harmony of the restoration, shade, shape, and value (Figure 32). At this stage of final treatment, we also observed the results of our efforts to achieve optimal tissue reaction (Figure 33 and Figure 34).

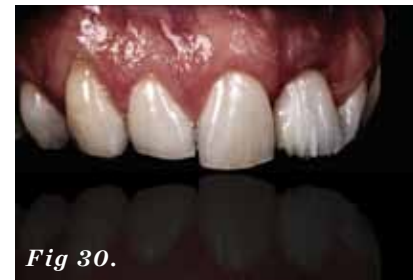
Fig 30. A segmental build-up was observed intraorally, showing the many layers applied to achieve a natural restoration.

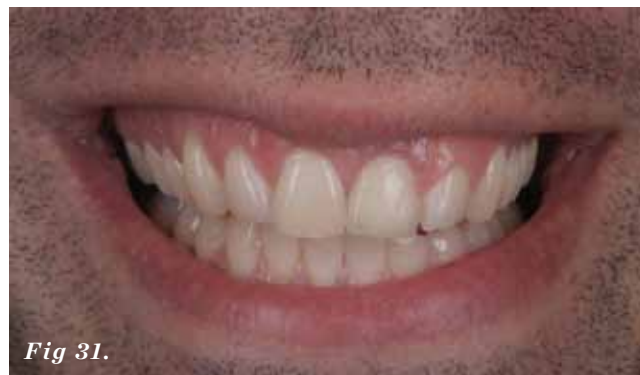
Fig 31. Try-in of the final crown at full smile.

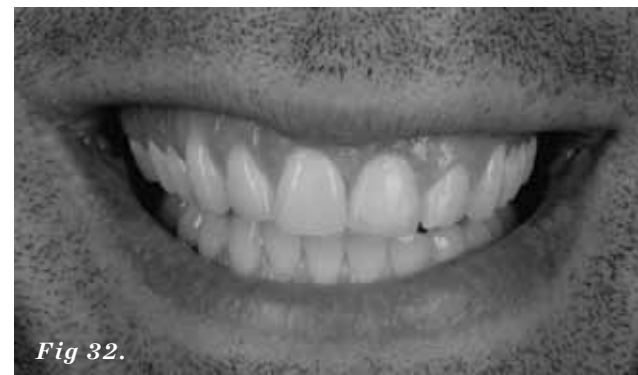
Fig 32. A value check is extremely important when restoring one tooth to see that there is no discrepancy with the surrounding dentition.

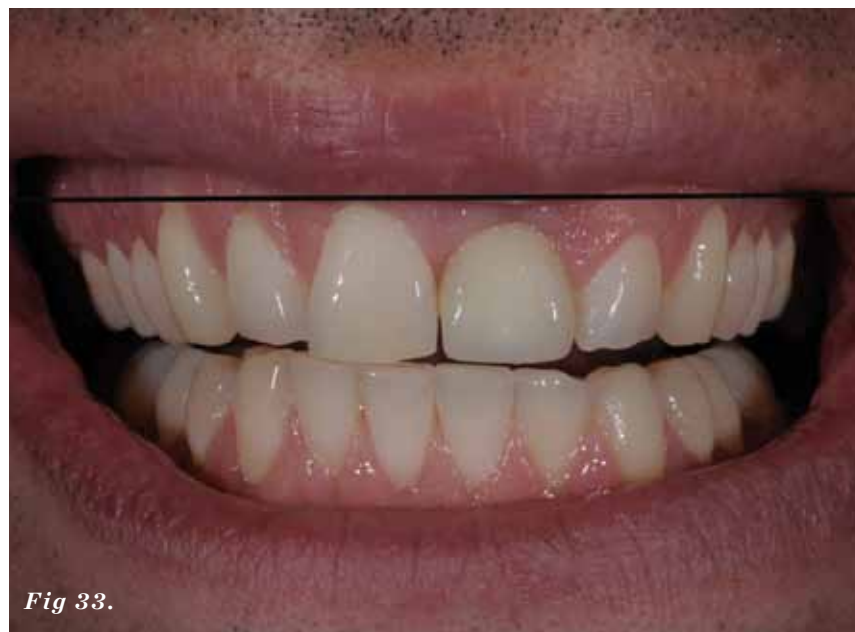
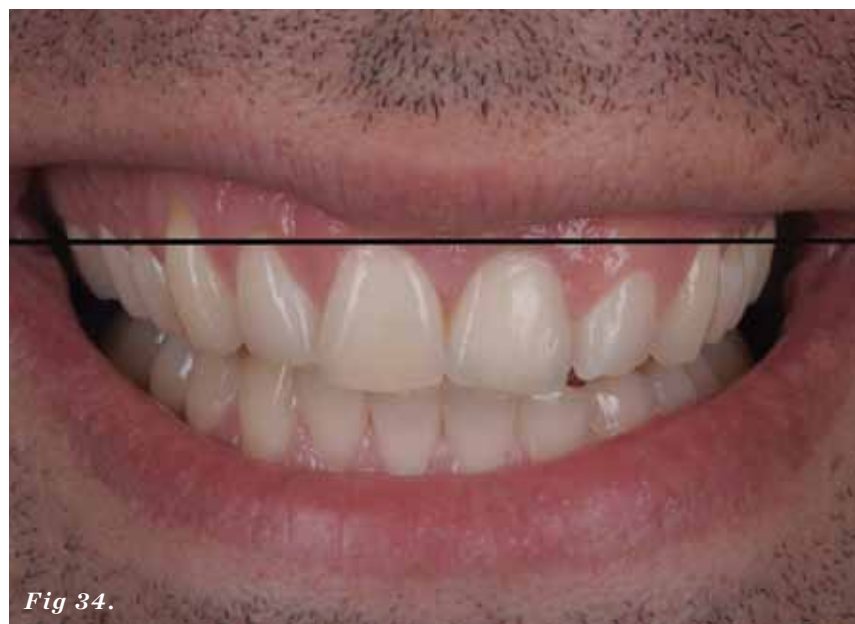
Fig 33.

Fig 33 and Fig 34. An observation of the corrected tissue height from the previous restoration was observed with a black line.

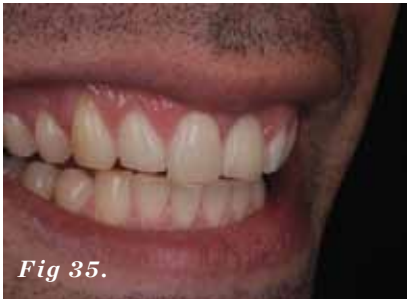
Fig 35. After wearing the crown for a week, the patient observed from different angles that he wanted a small addition to the mesial aspect of the restoration.

The crown was temporarily cemented in place so that the patient could wear it for a week or two to ensure no other adjustments or corrections were needed before final cementation. At the final appointment, the patient had one request for an adjustment. He said that from different angles the mesial aspect was a hair short and he wanted it to be more even (Figure 35). This is the reason that we always temporarily cement before the final cementation, to be sure that the patient is happy with our efforts before going to a final. Using low-fusing add-on powder from the GC Initial Zirconia kit, the technician added a small addition to the mesial aspect of the restoration to even the mesial-incisal edge (Figure 36). While we always want to improve our patients' overall smile, we also have to consider the appearance of the restoration with other facial expressions, such as lips at rest (Figure 37). Once all the details of this case came together, the satisfied patient felt confident with his new smile (Figure 38). Even though this case was only a single central incisor, a great deal of thought and consideration was necessary to achieve successful treatment and a life-like final outcome (Figure 39 through Figure 41).

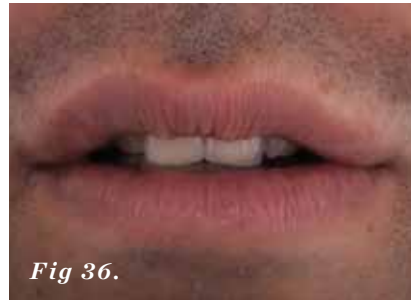
Fig 36. Try-in of the added correction to achieve the desired mesial length.

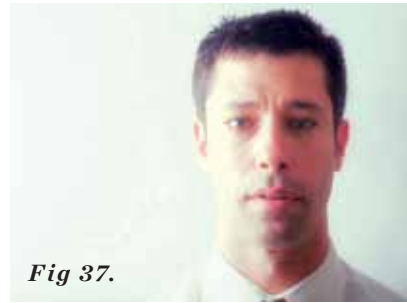
Fig 37. In the lips at rest position, it was clear to see that the small mesial detail was important for a successful outcome.
