JOSHUA POLANSKY, BA, MDC Owner Niche Dental Studio *Cherry Hill, New Jersey*

# **Becoming a Bench Top Clinician**

Looking beyond the technical for better esthetic results. By Joshua Polansky, BA, MDC

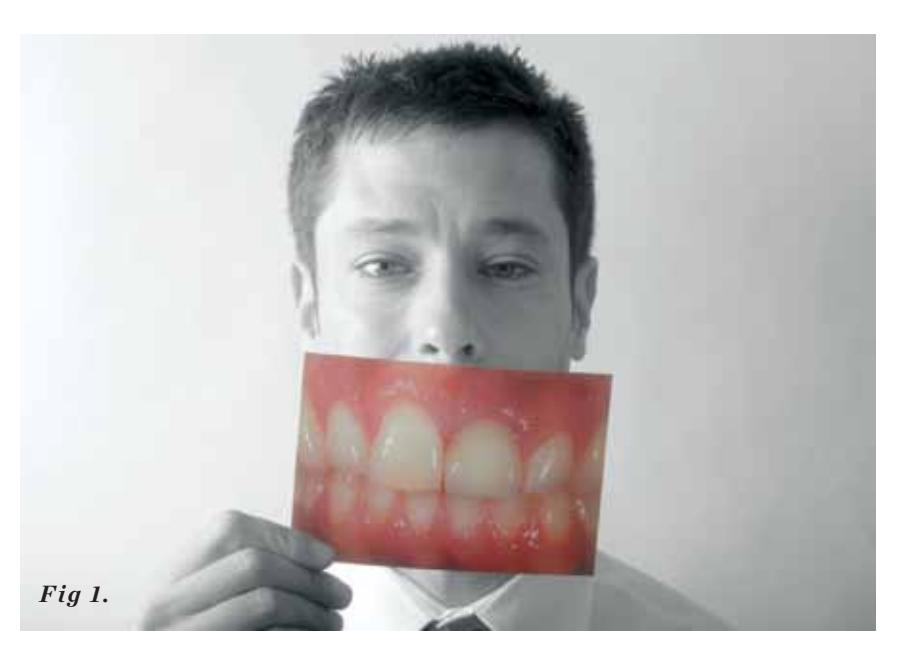
to reflect how happy he was on that day, rather than the unattractive smile he currently possessed. It was obvious that the patient's smile could be improved with additional treatment (Figure 1).

*Fig 1.* The patient's current situation as identified by another clinic. The patient was unhappy with the overall intraoral final outcome.

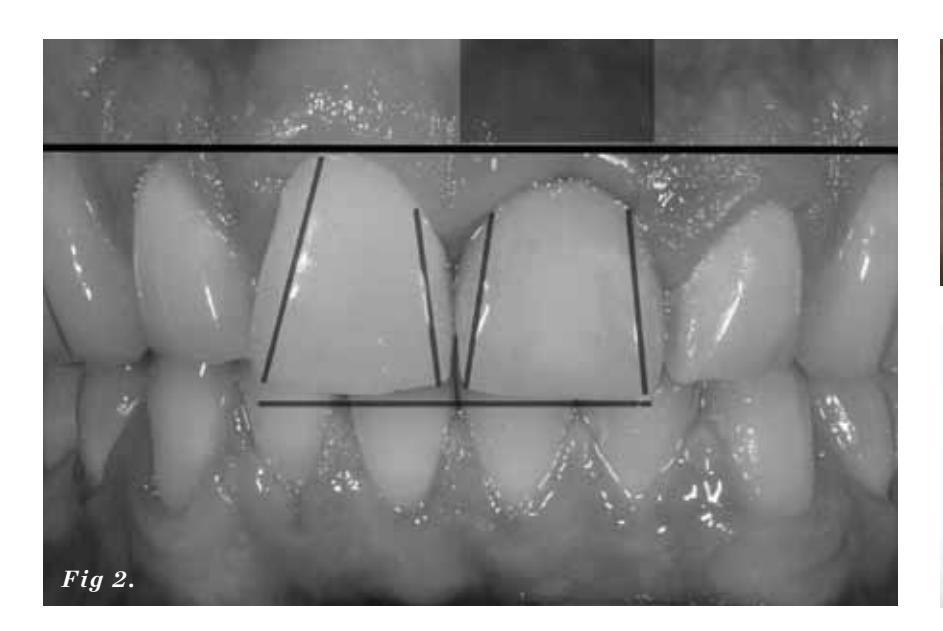
Intraoral photographs revealed details to help the dental team create a greatly enhanced restoration. The patient never mentioned a problem with the color of the restoration; his primary concerns centered on contour, form, and the disharmony created by the less than perfect restoration. Taking this into account, the color intraoral photographs were converted to black and white, which would allow the dental team to assess the patient's concerns (Figure 2). The black-and-white image showed that the restoration did not have the same form as the patient's natural dentition. Graying under the tissue from the metal abutment, an obvious tissue-level discrepancy, was also noted.

Fig 2. Getting away from color, the overall situation was analyzed. Form was an issue that had to be addressed to achieve success.

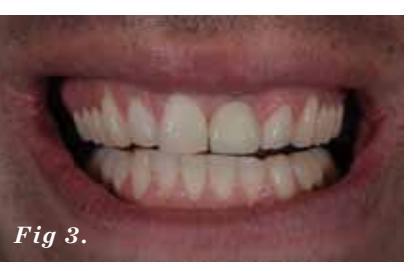
Technicians are inclined to look only at the model when restoring a case. However, to really achieve winning restorations, the patient's entire oral environment-including the tissue, lip line, and smile-needs to be studied. It was evident when examining this patient's lip line at full smile that the tissue-level discrepancy had to be addressed in order to reach an ideal outcome (Figure 3). Using photography to communicate the team's concerns aided in educating the patient. After being shown the intraoral images, the patient agreed with the dental team that in order to fully restore his situation, not only did the form of the restoration

Fig 3. The smile view shows the lip line issue that the team was faced with.

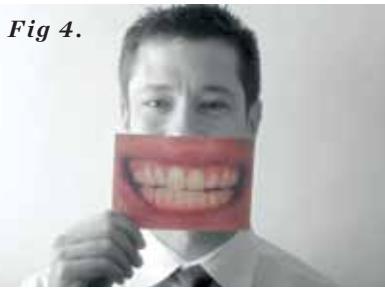
Fig 4. After reviewing the findings with the patient, he realized the treatment necessary to correct his current unesthetic overall appearance.

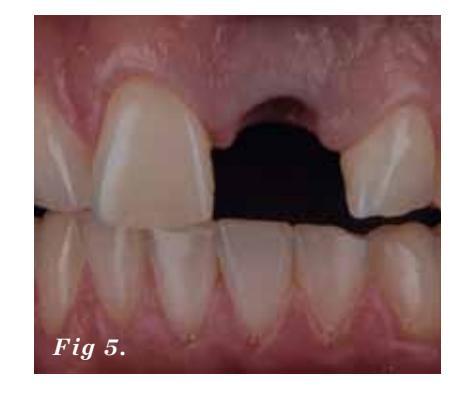
After the patient accepted the plan, the first step was to identify the type of implant placed. To obtain the necessary parts, the surgeon who placed the implant was called. The clinician removed the old restoration and observed the form of the surrounding tissue. It was very clear that the tissue-level discrepancy needed to be modified for an optimal case outcome (Figure 5). To save time and extra expense, the clinician was very careful when removing the old restoration so that the existing implant abutment could be salvaged (Figure 6). If necessary, a temporary abutment was available for placement.

Fig 5. The removal of the old crown revealed the tissue line discrepancy.

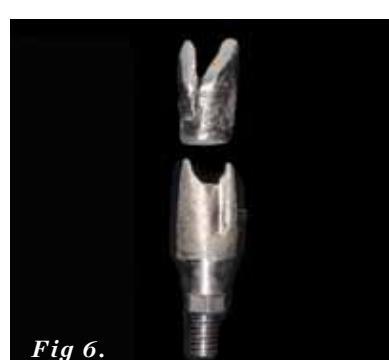
Fig 6. The doctor did a great job of salvaging the old abutment from the previous treatment. This abutment could now be used for the temporary phase.

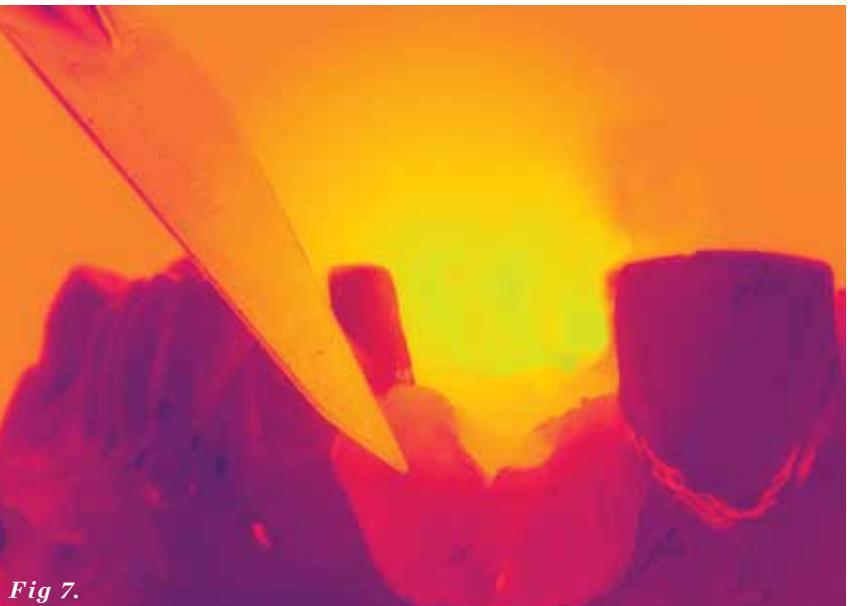
Fig 7. The soft tissue on the model could now be modeled to ideal contour.

With the old abutment and a softtissue impression of the existing situation, the technician could now go to the bench and, using a scalpel, contour the tissue on the model to ideal contours (Figure 7). The technician used the old abutment to recontour the sulcus area to a new ideal situation. This was done by priming the old abutment using GC Metal Primer 11 (GC America, www. gcamerica.com) and adhering composite (GC Gradia) to the abutment to create the optimal sulcus contour (Figure 8). Once the tissue and sulcus modifications were completed on the model, the technician could now fabricate an esthetic temporary as well as build the tissue simulation (Figure 9). An esthetic temporary was fabricated using Anaxdent New Outline acrylic (www.microstardental.com) with a highly polished custom temporary abutment (Figure 10).

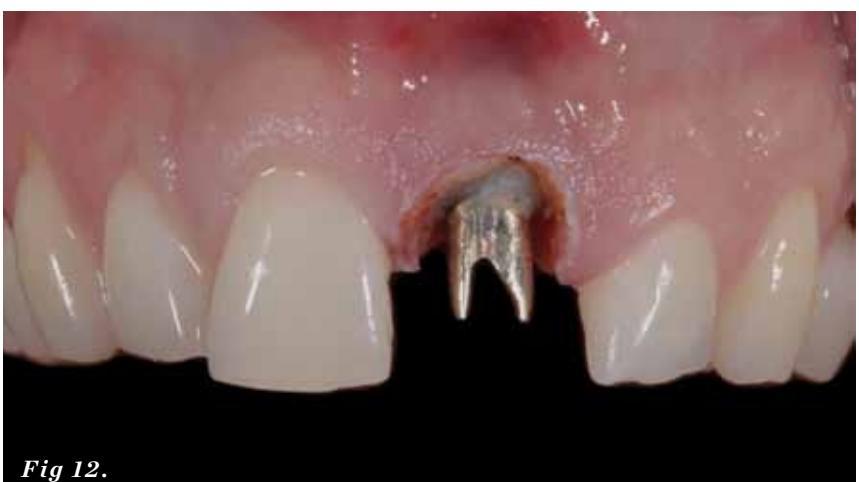
*lg 12*.

*Fig 12.* The tissue was contoured to the ideal highly polished Gradia custom abutment. The margin was in its ideal proposed place from the model.

The bench-top work completed by the technician could now be transferred to the patient's mouth. The clinician placed the new temporary abutment in the mouth and marked the tissue contours for cut-back (Figure 11). The tissue was contoured using a DEKA CO<sub>2</sub> soft-tissue laser (DEKA Laser Technologies, Inc., www.dekalasers. com). Once contoured, it became clear that the highly polished composite margin was ideally placed (Figure 12). The clinician used temporary cement to secure the provisional restoration in place and begin the tissue-healing phase of the treatment (Figure 13). The patient returned a week later for a clinical monitoring of tissue progress. For the dental team, it was important to observe not only that the tissue was healing nicely, but also that the form and color of the temporary matched the patient's expectations of the final case outcome (Figure 14). The team wanted to be sure it was headed in the right direction in terms of form, value, and tissue height (Figure

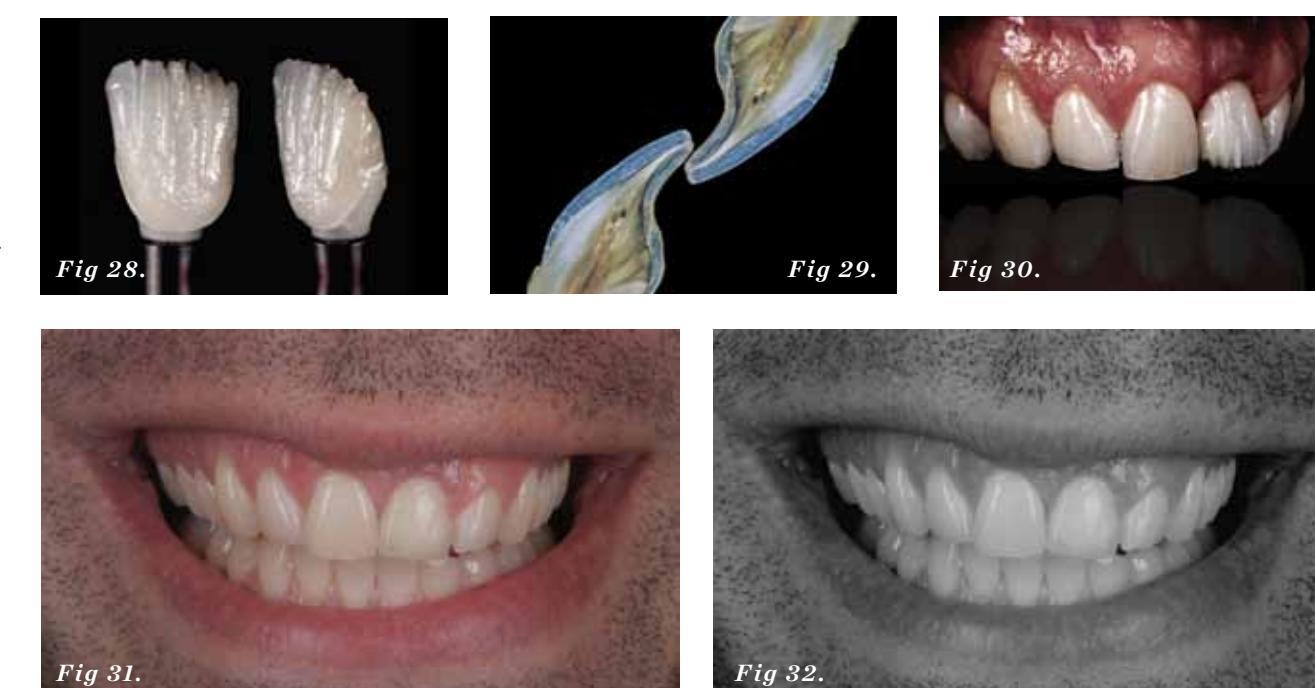
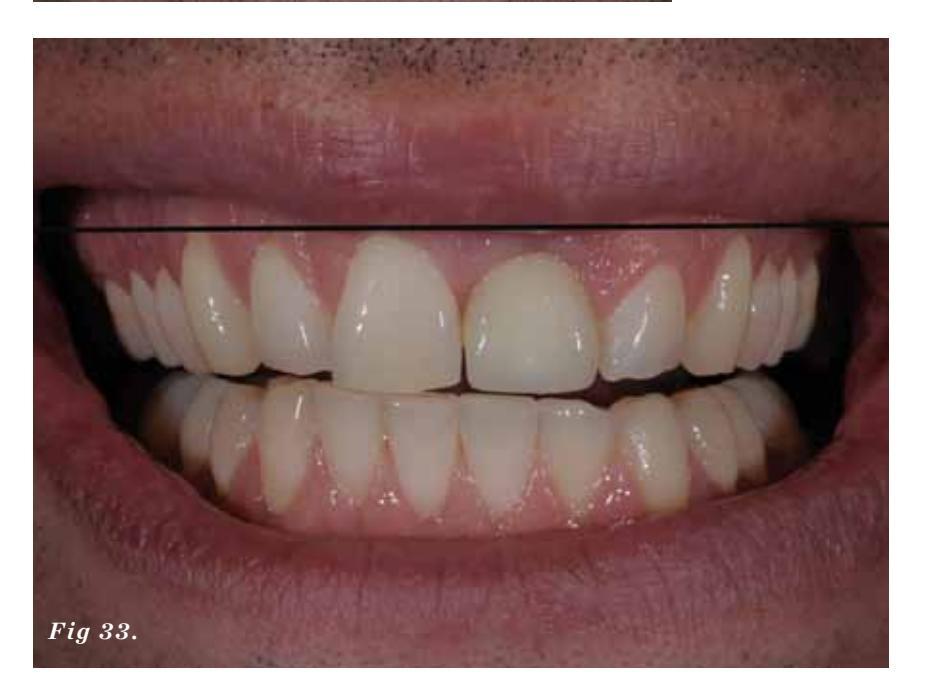
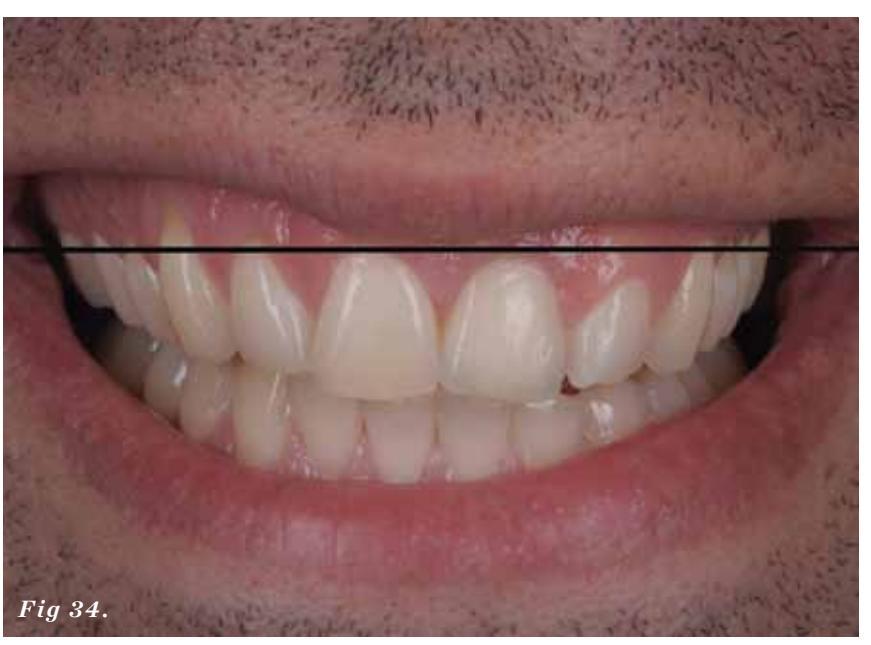
*Fig 28 and Fig 29.* A study of the layered crown shows a deep understanding of the observation of natural dentition.

*Fig 30.* A segmental build-up was observed intraorally, showing the many layers applied to achieve a natural restoration.

*Fig 31.* Try-in of the final crown at full smile.

With the base layer placed, polychromatic ceramic layering was begun always following the principles of nature (Figure 28 and Figure 29). Although the proposed restoration was a basic A1 shade, a deep understanding of a segmental ceramic layering technique should be understood. The layers of deep dentins, modifiers, enamels, translucence, and opalescent ceramics are catalysts for the diffusion, transmission, and scattering of light that will allow for a life-like restoration. Figure  $30\,\mathrm{shows}\,\mathrm{the\,segmental\,layering\,for\,the}$ proposed restoration. Note the multiple layers of dentins, effects, and opals used to achieve the final result. Once the ceramic layering was complete, the crown was tried in for final analysis (Figure 31). For this analysis, the team looked at the overall natural harmony of the restoration, shade, shape, and value (Figure 32). At this stage of final treatment, we also observed the results of our efforts to achieve optimal tissue reaction (Figure 33 and Figure 34).

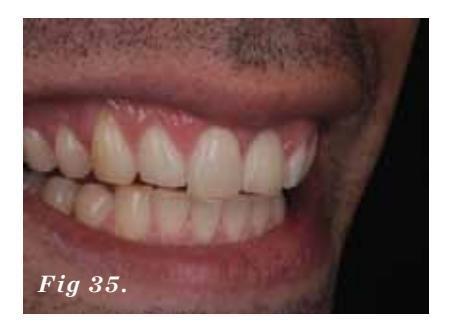
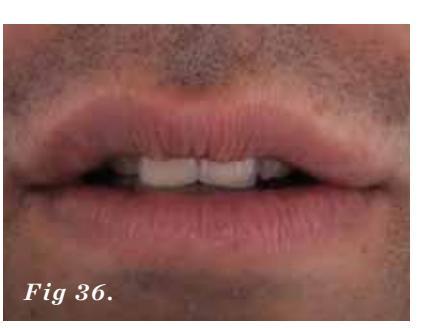
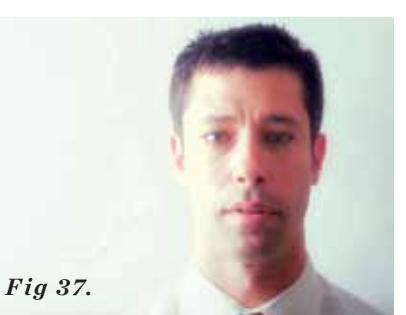
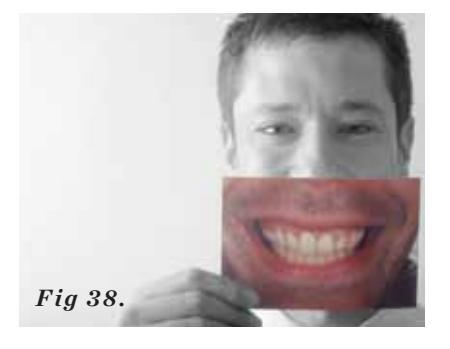
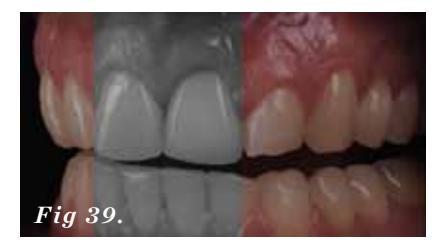
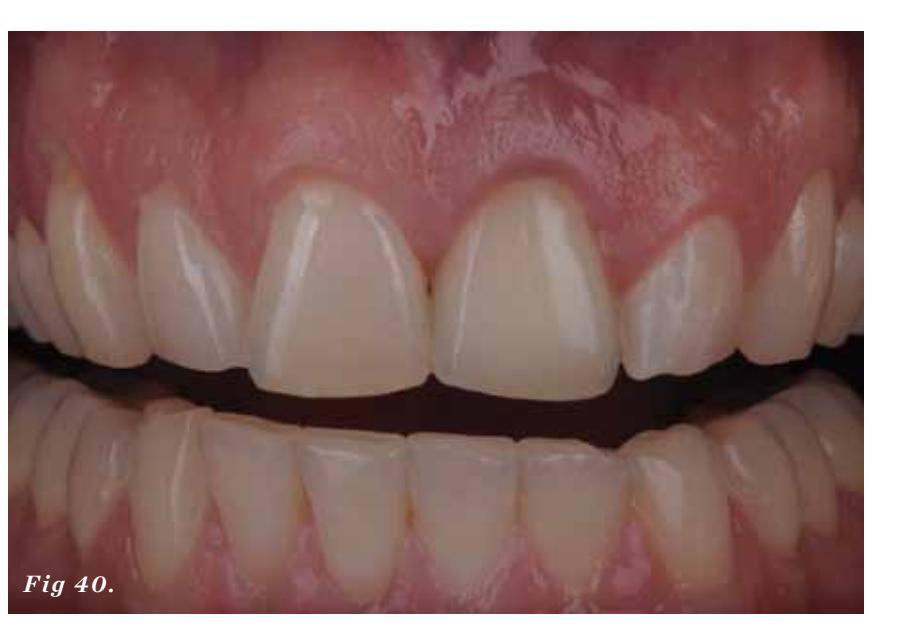
*Fig 35.* After wearing the crown for a week, the patient observed from different angles that he wanted a small addition to the mesial aspect of the restoration.

*Fig 36.* Try-in of the added correction to achieve the desired mesial length.

*Fig 37.* In the lips at rest position, it was clear to see that the small mesial detail was important for a successful outcome.

*Fig 38.* With a happy patient, clearly the details are what made this case a success and gave the patient the smile he desired.

*Fig 39. through Fig 41.* Postoperative results.

The crown was temporarily cemented in place so that the patient could wear it for a week or two to ensure no other adjustments or corrections were needed before final cementation. At the final appointment, the patient had one request for an adjustment. He said that from different angles the mesial aspect was a hair short and he wanted it to be more even (Figure 35). This is the reason that we always temporarily cement before the final cementation, to be sure that the patient is happy with our efforts before going to a final. Using low-fusing add-on powder from the GC Initial Zirconia kit, the technician added a small addition to the mesial aspect of the restoration to even the mesial-incisal edge (Figure 36). While we always want to improve our patients' overall smile, we also have to consider the appearance of the restoration with other facial expressions, such as lips at rest (Figure 37). Once all the details of this case came together, the satisfied patient felt confident with his new smile (Figure 38). Even though this case was only a single central incisor, a great deal of thought and consideration was necessary to achieve successful treatment and a life-like final outcome (Figure 39 through Figure 41).
